# Navajo Abandoned Uranium Mine

# **Site Screen Report**

# **Upper Red Canyon AUM Site**

August 2010

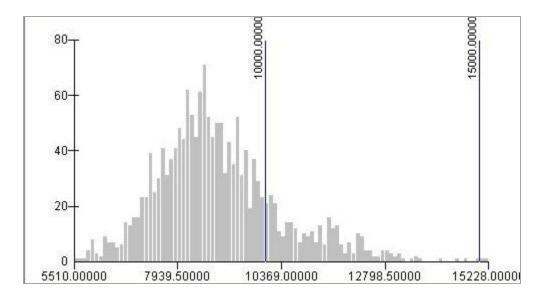
A total of 1,632 gamma radiation measurements were collected from the mine site, ranging from 5,510 cpm to 15,228 cpm. The measurements are represented in Figures 1 and 2.
